WEP Phase II Report

Non-Consumptive Needs Assessment

June 2021

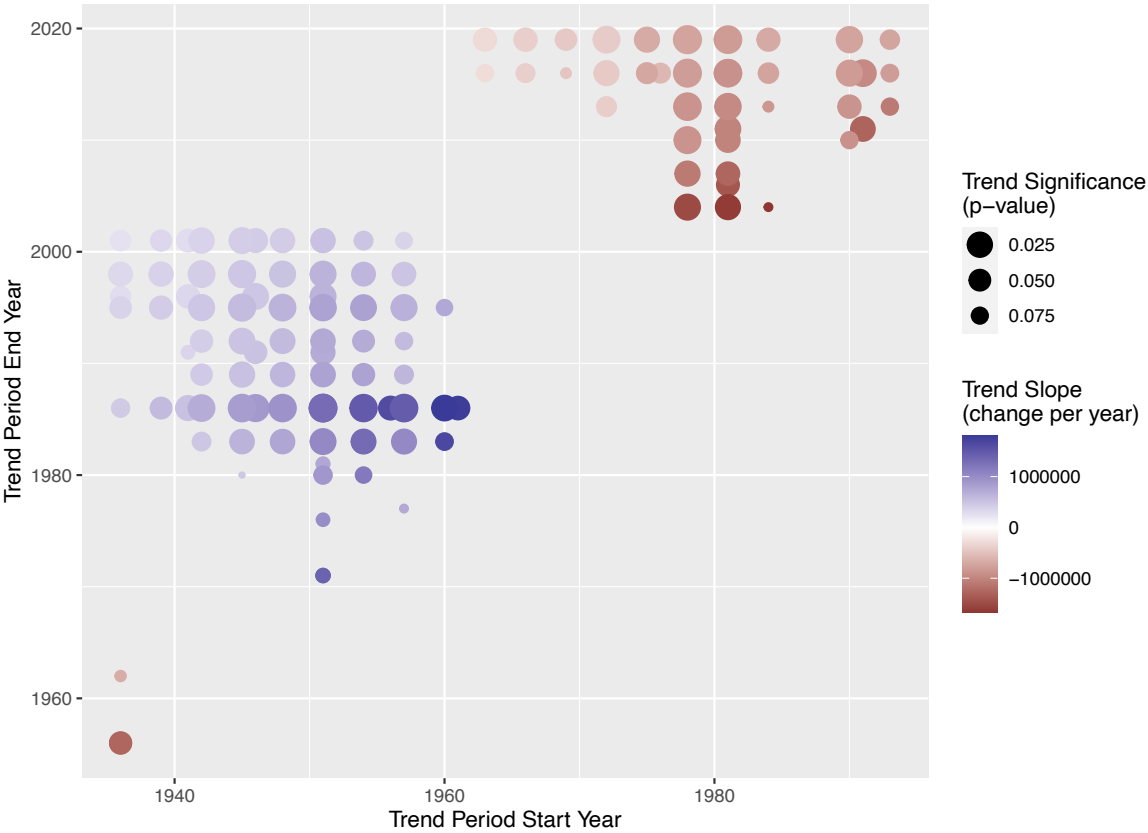
Figure 15. Trends in Jul-September volumes (trend slope values are in cubic meters) for the San Juan River at Pagosa Springs observed over various time period in the 20th century. A period of unusually large snowfall in the early 1980s drives an upward trend between the 1940s and 1980s. From the 1960s to the present, a persistent downward indicates declining runoff volumes during the summer months.

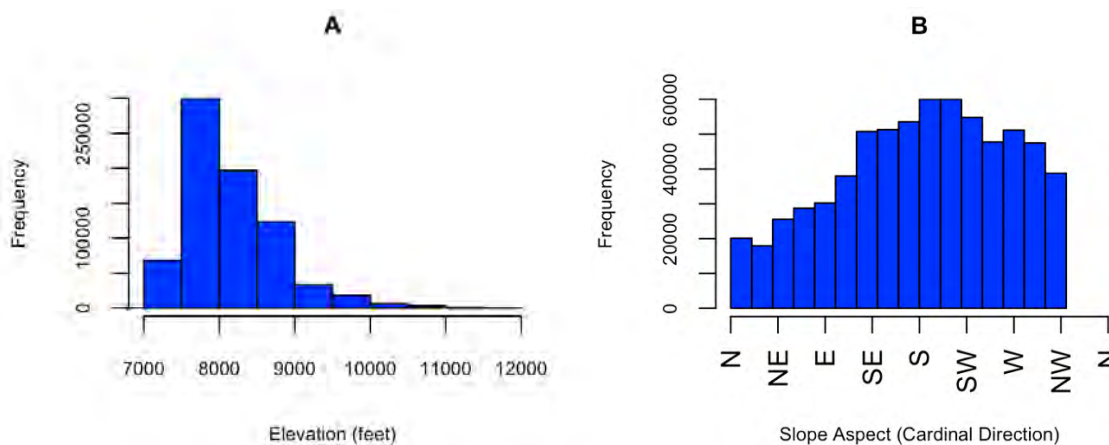
Figure 18. Distributions of landscape positions where a statistically significant trend toward earlier snowmelt was observed. Left: distribution of elevation values exhibiting earlier melt times. Right: distribution of slope aspects exhibiting earlier melt times.

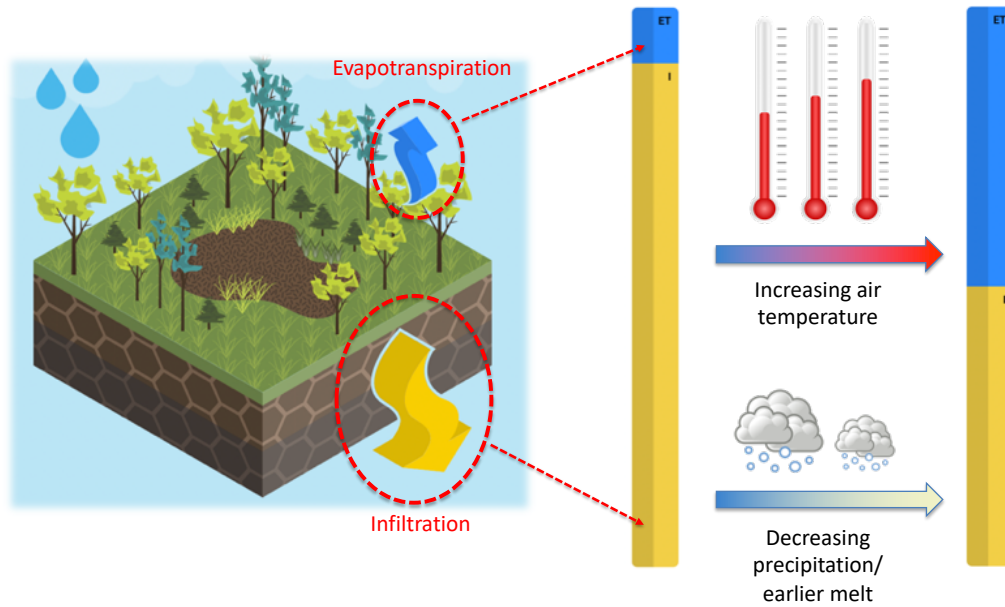
Figure 20. Increasing summer air temperatures and decreasing precipitation or earlier snowmelt is expected to lead to increased evapotranspiration by plants, a reduction in soil moisture, and a reduction in the amount of snowmelt that makes its way to groundwater via infiltration and, subsequently, contributes to flows in streams and rivers. Soil moisture is expected to exert a strong control on late-season baseflows. (Graphics modified from Stroud Research Center⁴⁰)

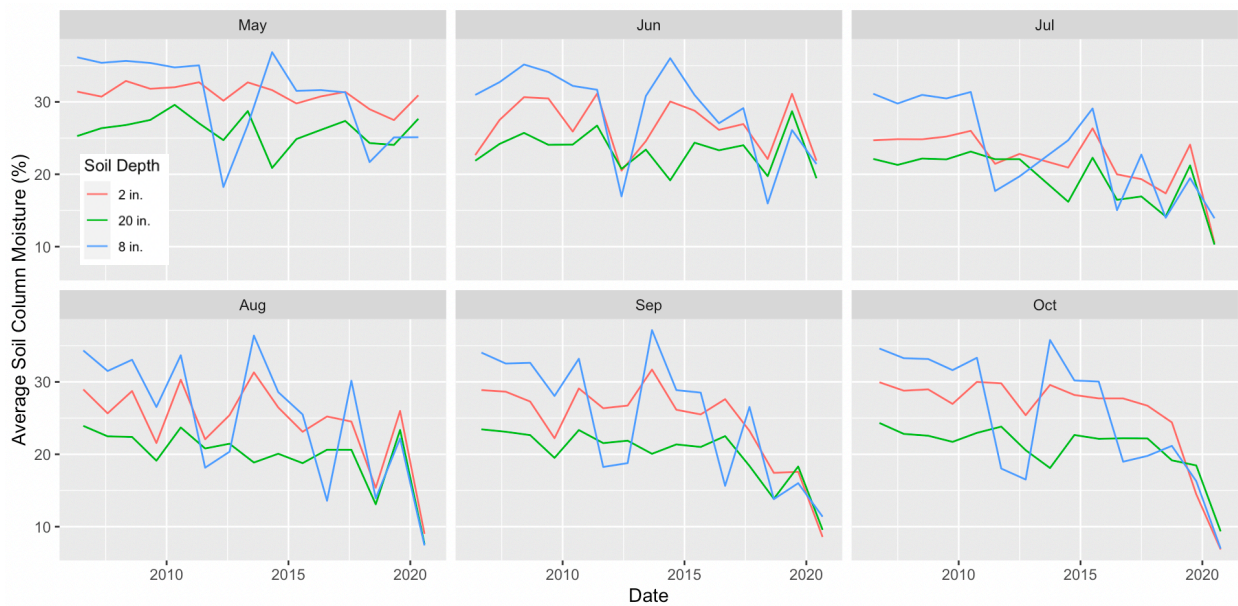
Figure 21. Average monthly soil moisture characteristics observed at three soil depths at the Upper San Juan and Wolf Creek Summit SNOTEL sites between 2005 and 2020. A negative downward trend is particularly evident in the late summer and fall months over the 2015-2020 period. No historical soil moisture data is available for lower elevations in the WEP planning area.

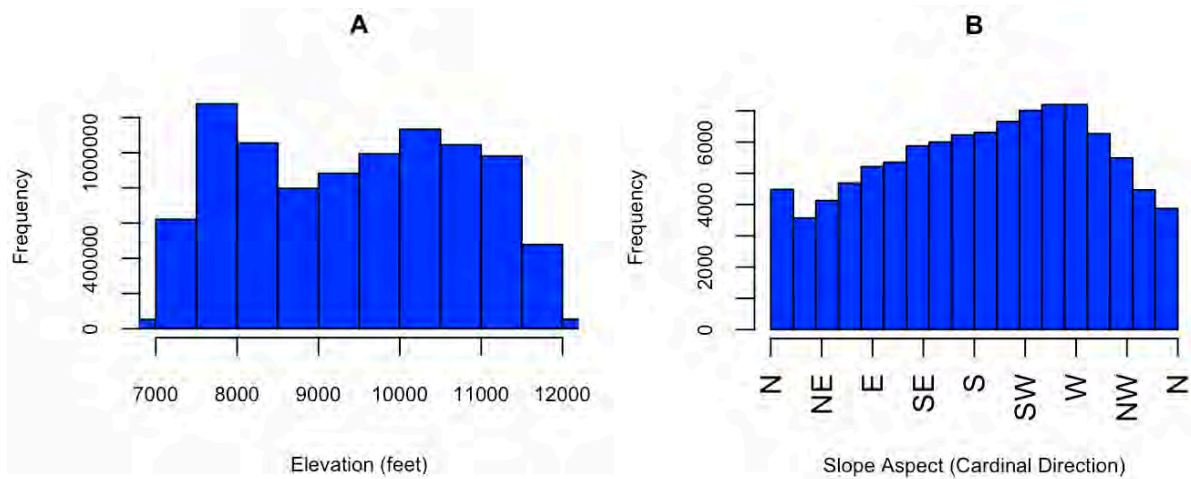
Figure 22. Distributions of landscape positions where a statistically significant trend toward decreasing NDWI was observed. Left: distribution of elevation values exhibiting decreasing NDWI values. Right: distribution of slope aspects exhibiting decreasing NDWI values.

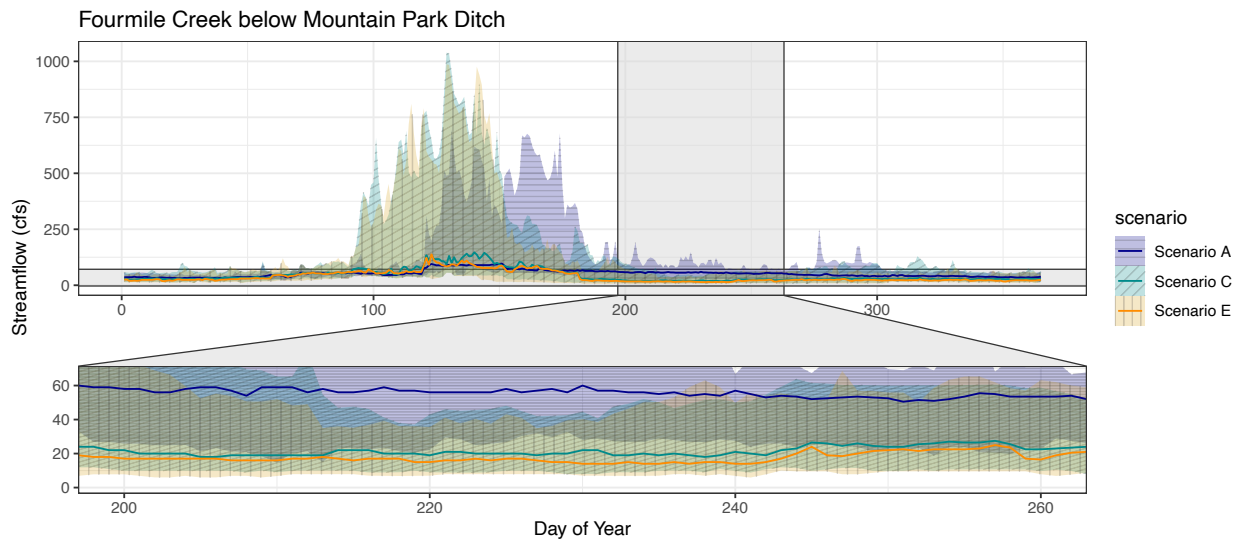
Figure 30. Hydrological regime behaviors for Fourmile Creek below Mountain Park Ditch modeled under three scenarios from the Technical Update to the Colorado Water Plan. Solid lines indicate mean daily flow values across the full simulation period, shaded areas indicate full range of daily flow values observed across the simulation period for a given scenario.

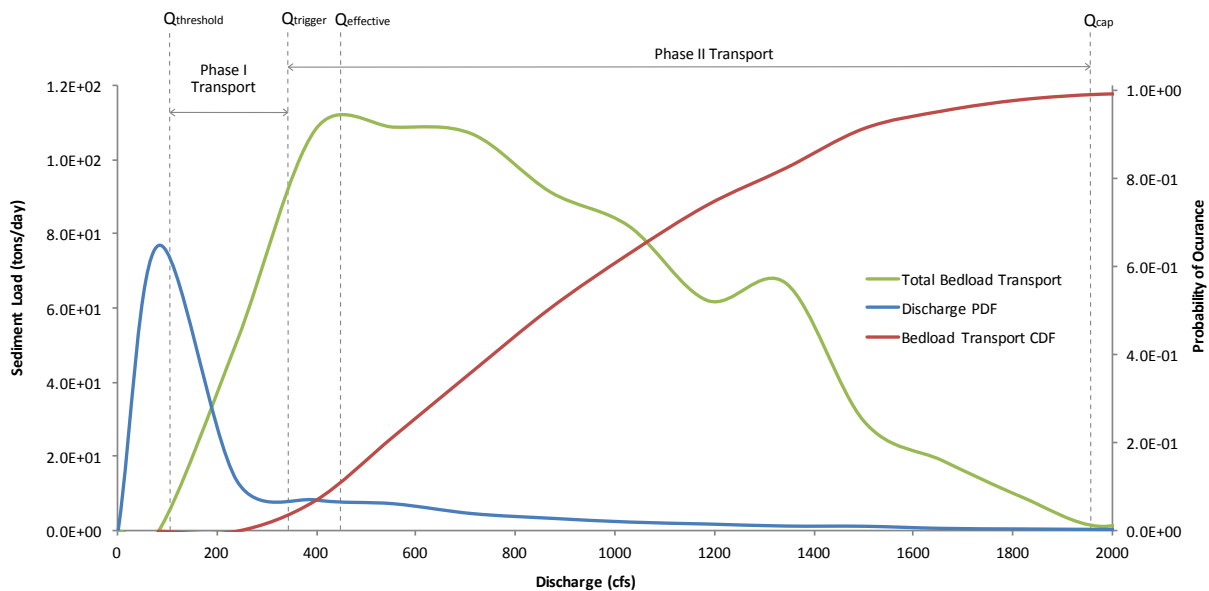
Figure 33. Example magnitude-frequency plot estimating the mass of sediment transported through a channel cross-section across a range of discharges. Total bedload transport results are a function of the hydraulic characteristics of the cross section and the probability of occurrence of various flow states along the interval.

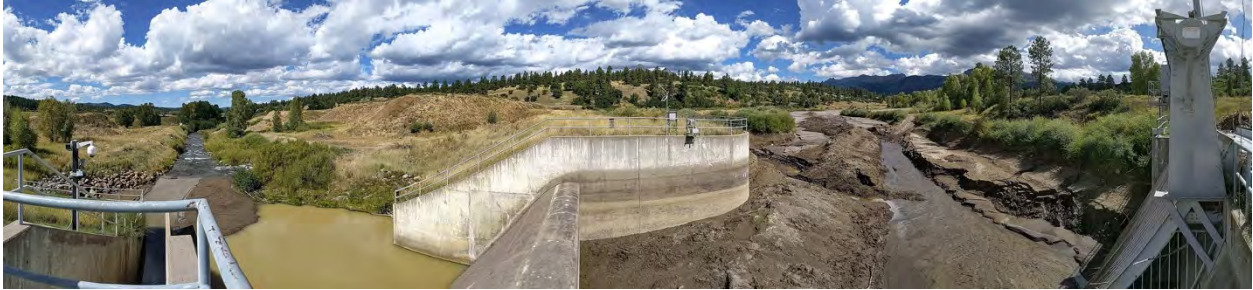
Figure 34. Evidence of sediment removal activities on the upstream side (image-right) of the Oso Diversion Dam on the Navajo River.

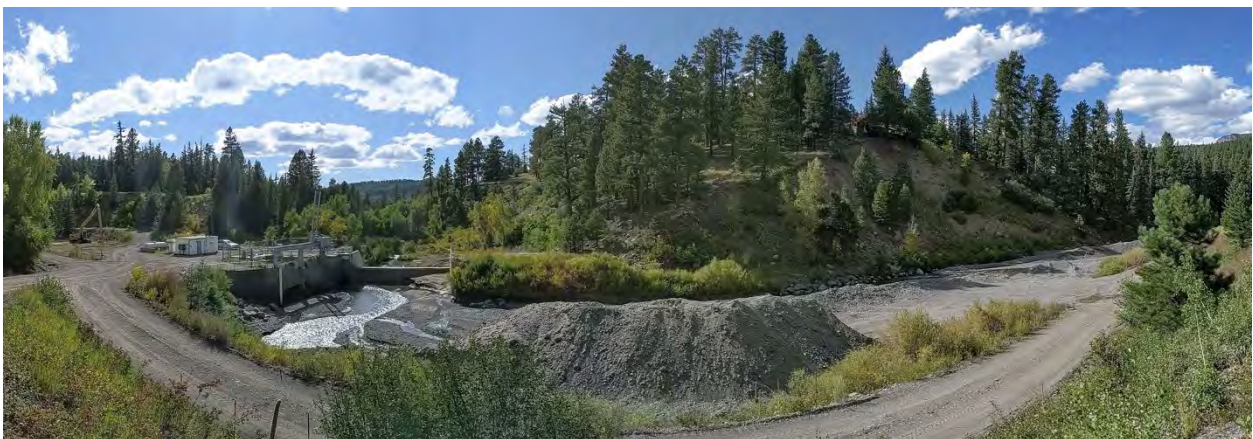
Figure 35. Evidence of sediment removal activities (image-center) on the upstream side of the Blanco Diversion Dam on the Rio Blanco.

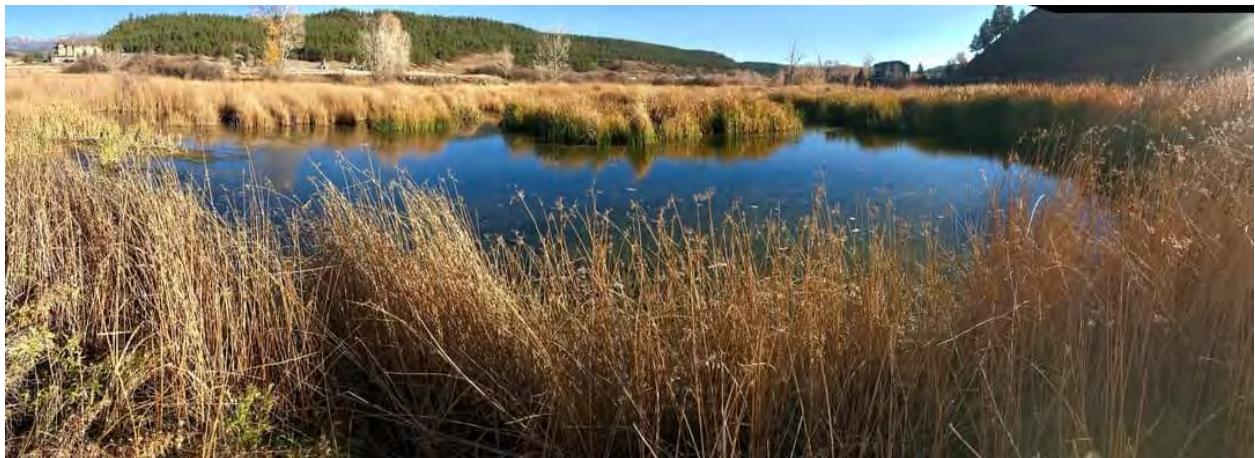
Figure 38. A view of the Town of Pagosa Springs Wetlands, one of the most unique riparian wetlands in the WEP planning area. (Photo credit: Brenda Breeding)

The hot springs wetlands in Pagosa Springs are designated by CNHP as a Site of Local Significance. These wetlands are home to rare and unique plant communities supported by outflows from the Pagosa Hot Springs. Threats to the function and quality of these wetlands include modification of the timing and quantity of flows received by the hot springs, development and urban runoff from adjacent lands, and invasive plant species. The unique characteristics and management needs for these wetlands are also presented by Pagosa Wetland Partners.⁶⁷ Preservation of this unique wetland complex may require the development of a long-term agreement between the Town of Pagosa Springs and the private entity that manages return flows from the Pagosa Hot Springs. Such an agreement would need to ensure that the wetlands receive an adequate supply of geothermal water to maintain the existing community structure. Determination of the timing, quantity, and frequency of water deliveries to the wetlands may require a detailed, site-specific study. Stakeholders may benefit from focused consideration of these opportunities in the next phase of planning.

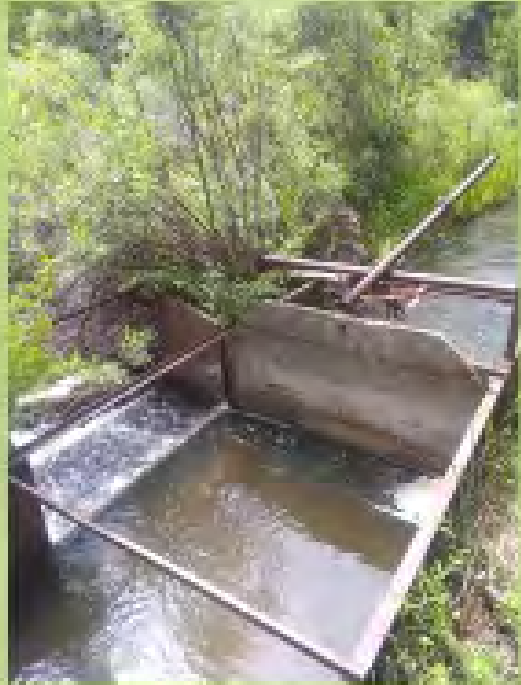
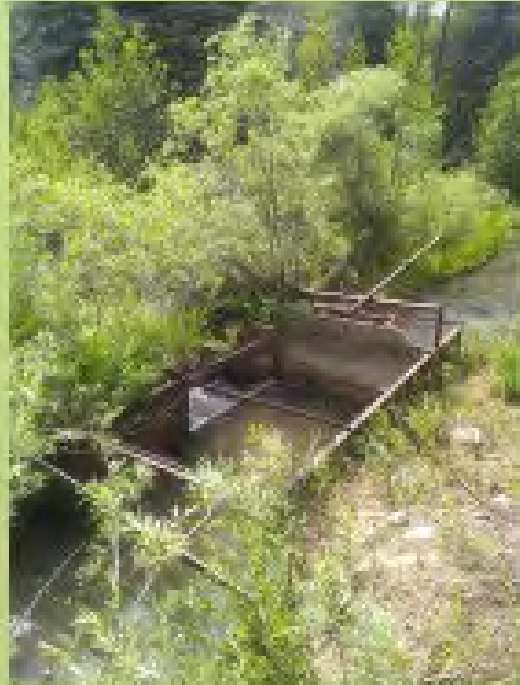
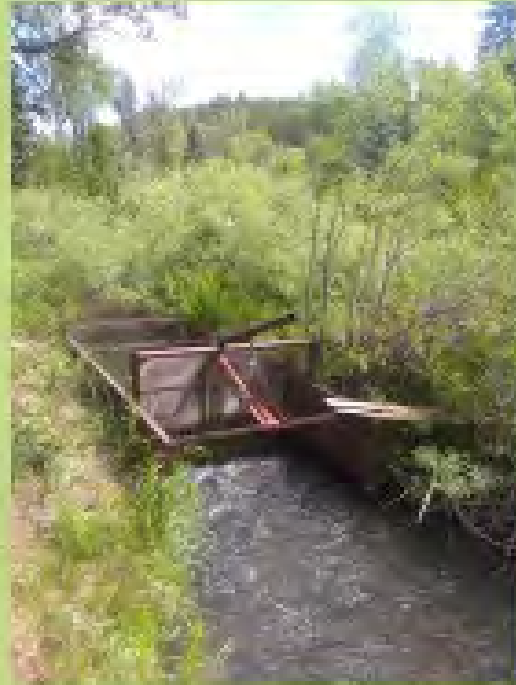
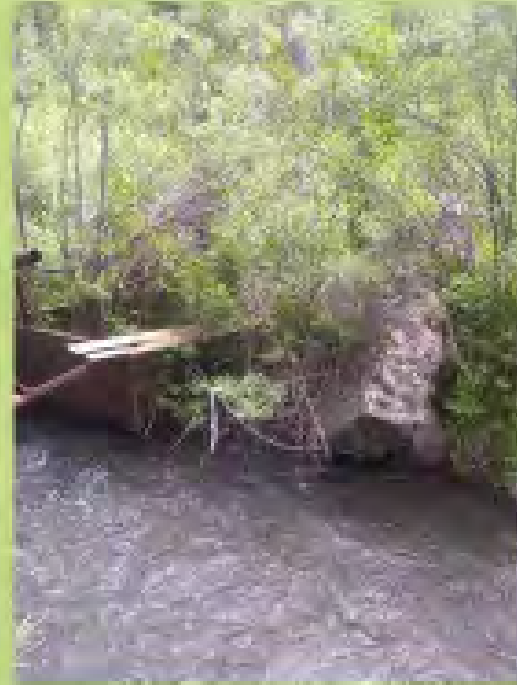
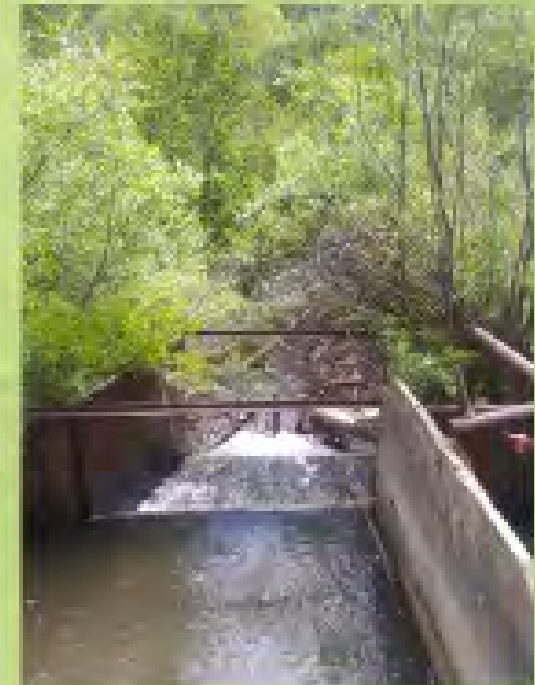
Division Box Photos

Photos that correspond to above Sample Point:

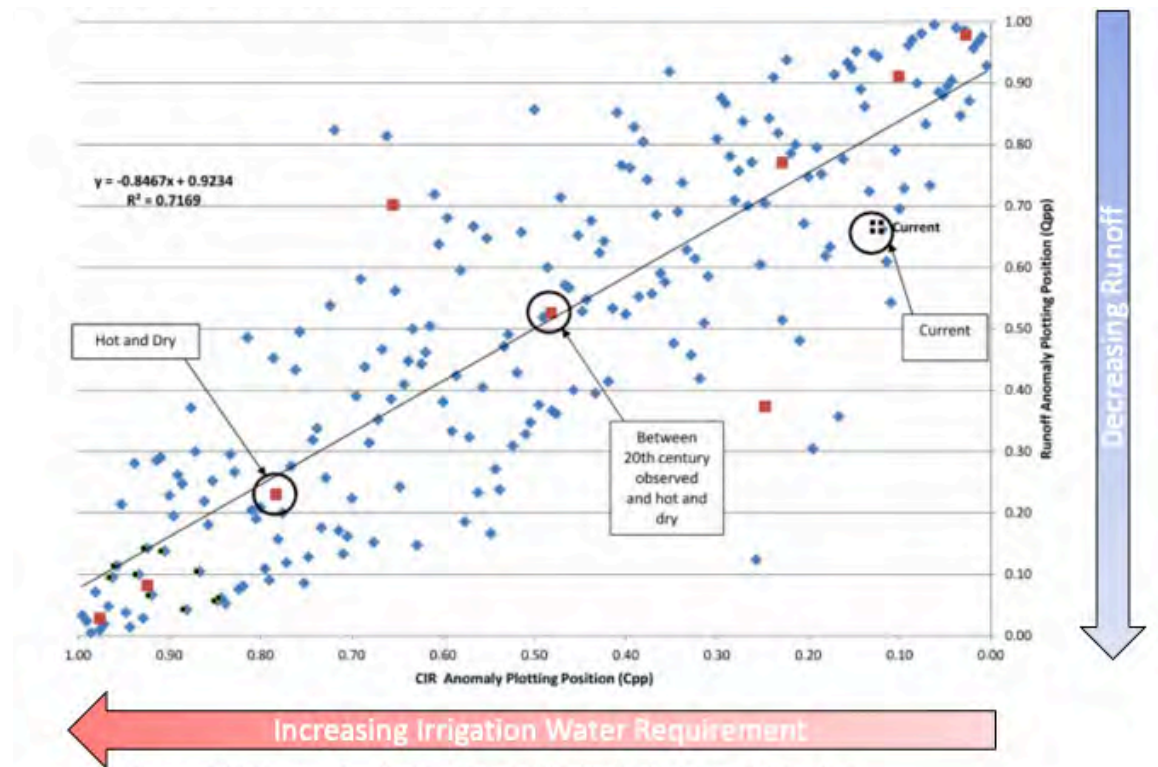
Figure 6. Three climate scenarios selected for use in the Technical Update models bracket the range of Runoff Anomalies and Crop Irrigation Requirements predicted by a large number of climate models/runs.

The climate scenarios included in the Technical Updates models attempt to bracket the range of future conditions predicted by a large number of climate models (Figure 6). Scenarios A and B represent climate using historical patterns of hydrology, temperature and precipitation. Scenarios D and E represent a future climate where runoff anomalies decrease (streamflows decrease) and Crop Irrigation Requirement (CIR) anomalies increase (crop water use increases). Scenario C uses positions for runoff anomalies and CIR anomalies intermediate between the historical condition and the hot-and-dry future characterized by Scenarios D and E.

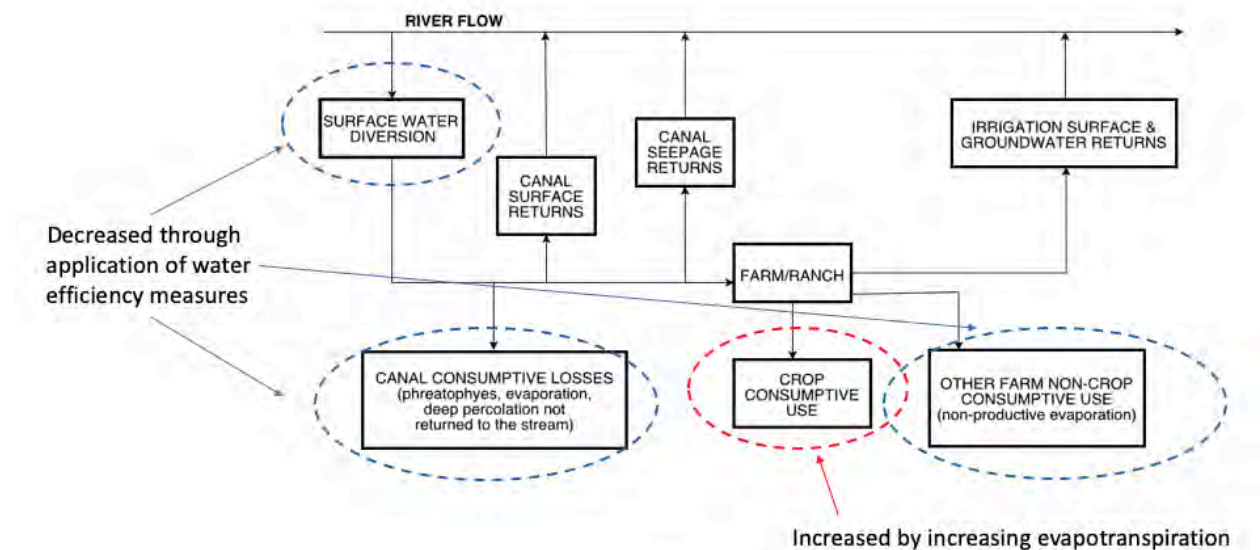
Figure 7. The climate futures represented by Scenarios C, D, and E all include increases in crop consumptive use (red circle) that drives increasing diversion from streams and rivers to satisfy agricultural use demands. Scenarios C and D include water conveyance and application efficiencies that offset this increased demand through simulated introduction of efficiency measures (blue circles).

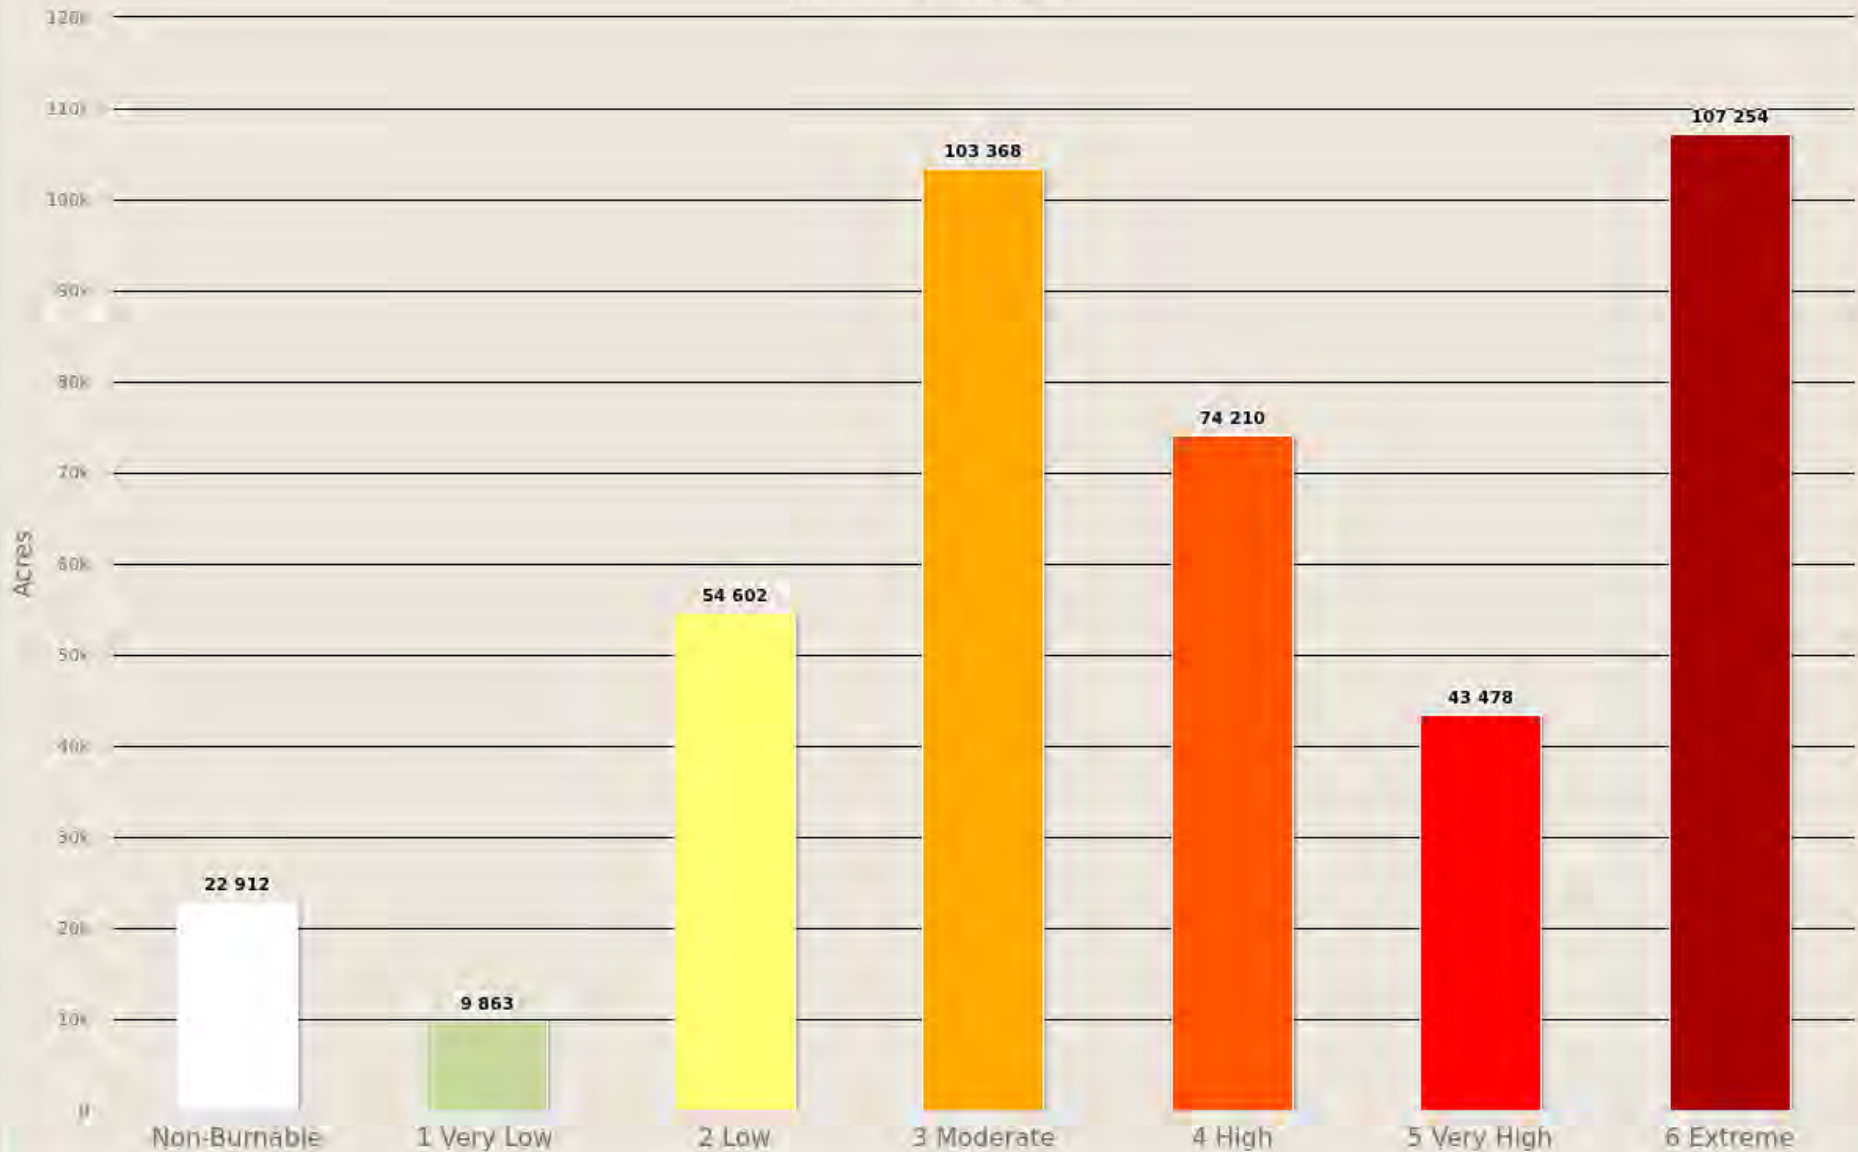
Characteristic Rate of Spread

Rate of Spread	Acres	Percent
Non-Burnable	22,912	5.5 %
1 Very Low	9,863	2.4 %
2 Low	54,602	13.1 %
3 Moderate	103,368	24.9 %
4 High	74,210	17.9 %
5 Very High	43,478	10.5 %
6 Extreme	107,254	25.8 %
Total	415,689	100 %

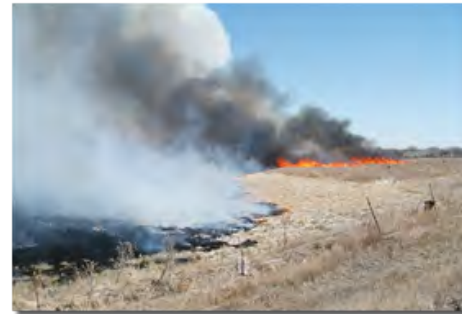
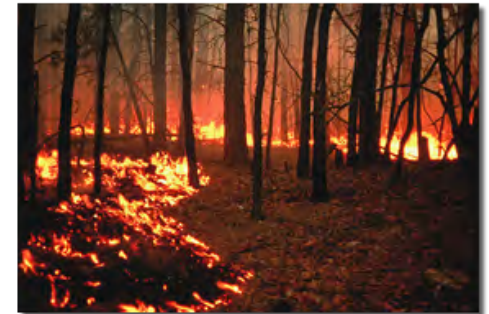
Surface Fire

A fire that spreads through surface fuel without consuming any overlying canopy fuel. Surface fuels include grass, timber litter, shrub/brush, slash and other dead or live vegetation within about 6 feet of the ground.

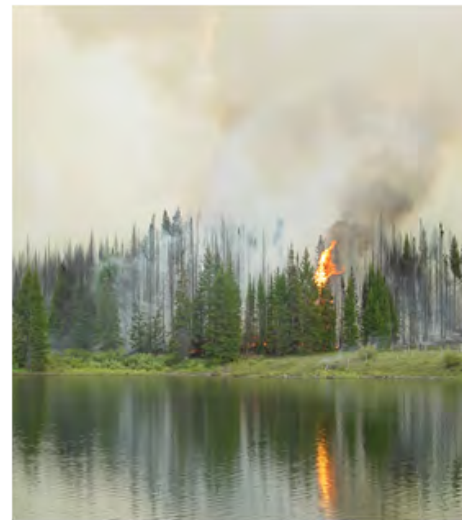
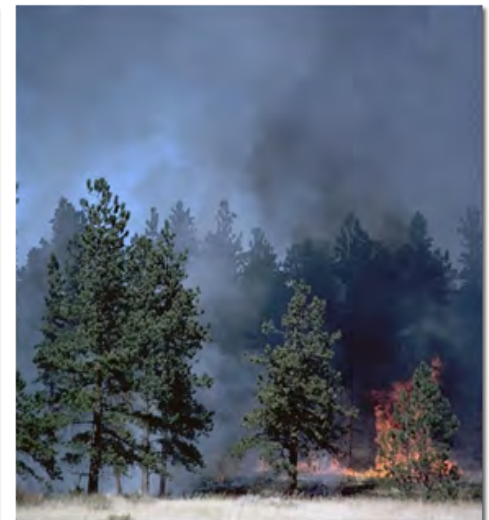
Passive Canopy Fire

A type of crown fire in which the crowns of individual trees or small groups of trees burn, but solid flaming in the canopy cannot be maintained except for short periods (Scott & Reinhardt, 2001).

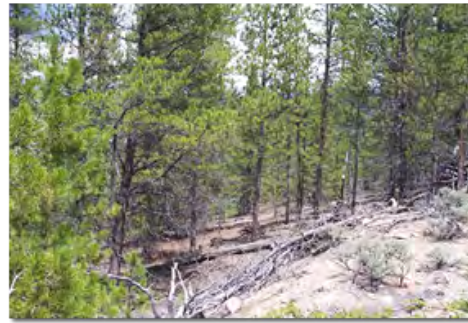
Unmanaged forest with dead and downed trees and branches

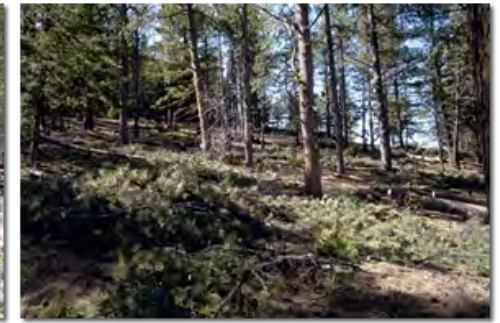
Slash on the ground indicates that forest management treatments have occurred in this area

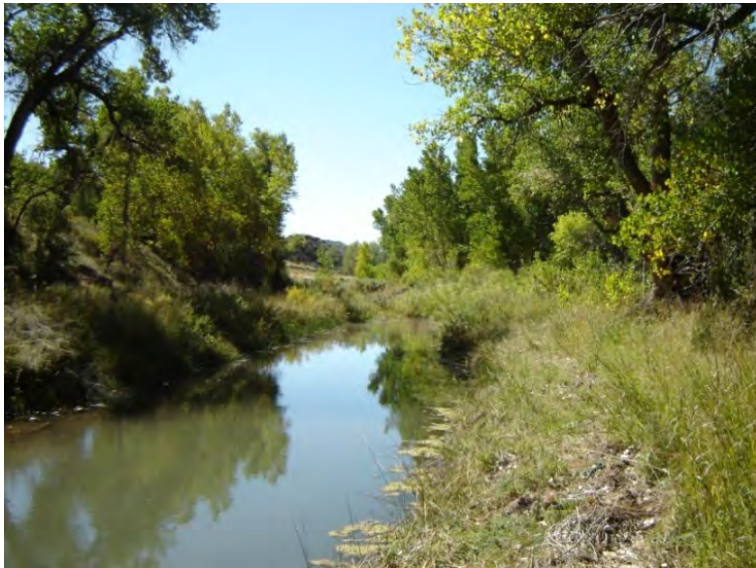
The process for defining these riparian areas involved identifying the riparian footprint and then assigning a rating based upon two important riparian functions – water quantity and quality, and ecological significance. A scientific model was developed by the West Wide Risk Assessment technical team with in-kind support from CAL FIRE state representatives. Several input datasets were used in the model including the National Hydrography Dataset and the National Wetland Inventory.

The National Hydrography Data Set (NHD) was used to represent hydrology. A subset of streams and water bodies, which represents perennial, intermittent, and wetlands, was created. The NHD water bodies dataset was used to determine the location of lakes, ponds, swamps, and marshes (wetlands).
